Fan Shaft Repair Same Day!

Repaired onsite at your location
within one day by methods of
thermal spray and grinding.

Powers Bros. On Site Fan Shaft Repair

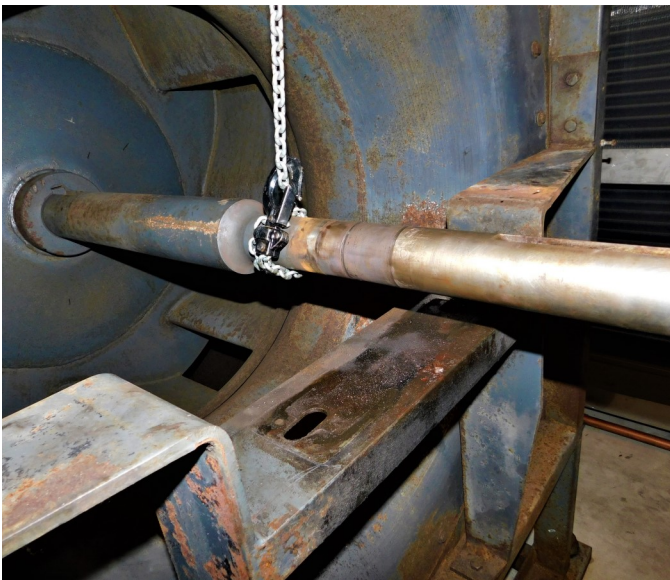
WORN BEARING AREA

Have you ever had a fan shaft with a worn bearing area, but the shaft was too large to remove?

Powers Bros has developed an on site process to repair the damaged bearing area while the shaft stays in the unit. The process includes metallizing (material build up) the damaged area and grinding the area back to factory size.

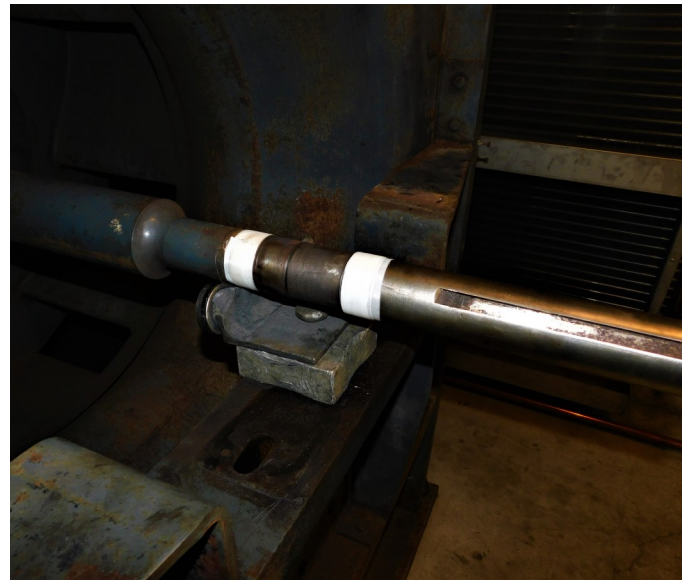
SHAFT PREPARED

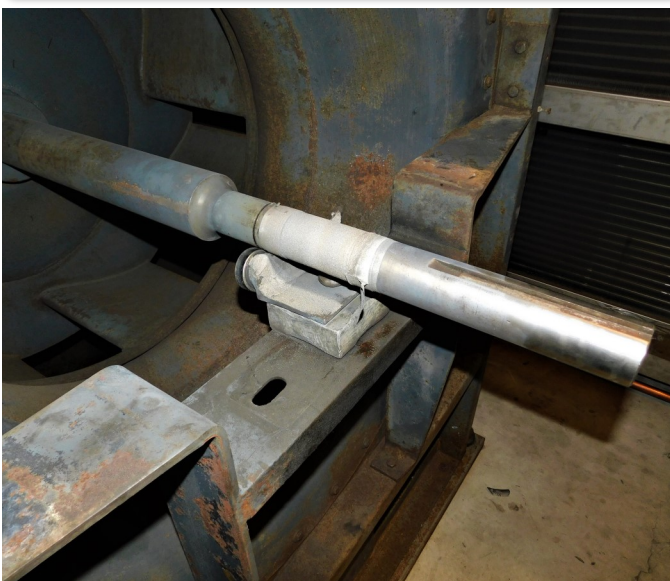
FINISH GRINDING

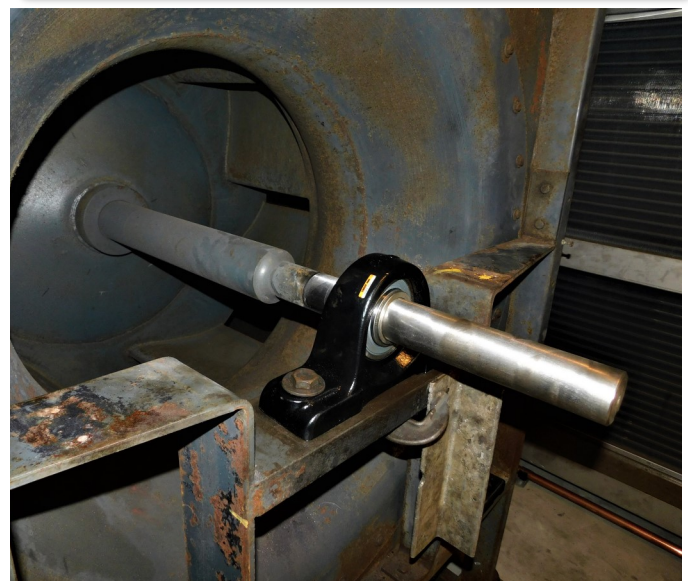
FINISH SIZE FOR BEARING

What you get is a good surface finish and a harder surface ready for a bearing.

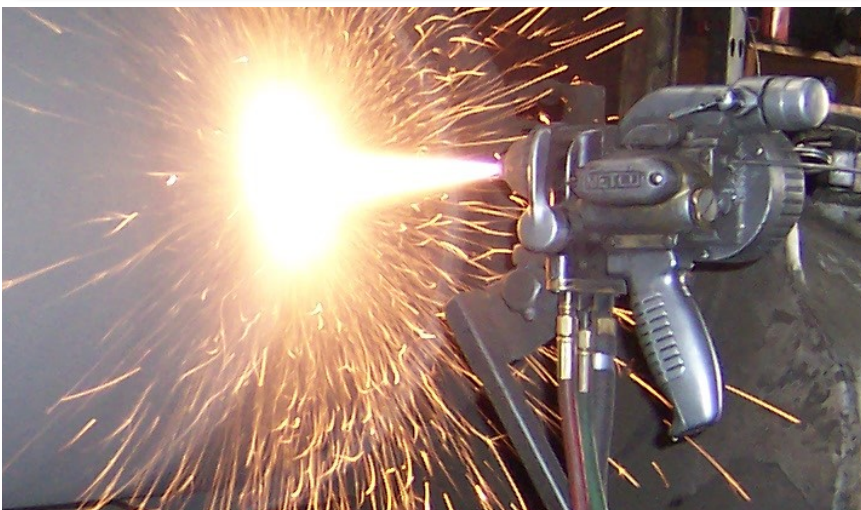
METALLIZING

Metallizing is a technique of coating metal on the surface of objects. Metallic coatings may be decorative, protective or functional. Techniques for metallizing fan shafts involves starting with a combustible gas, oxygen, compressed air and an alloy. The gas/oxygen mix melts the alloy and the compressed air combined with the metallizing gun sprays the molted alloy onto the object. Learn more about Thermal Spray at, PowersBros.com
